Catalina 310

The Eternal Coolant Leak

Fuel System Modification

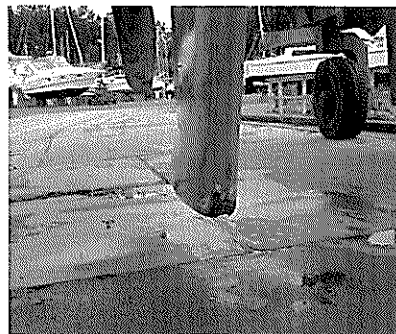
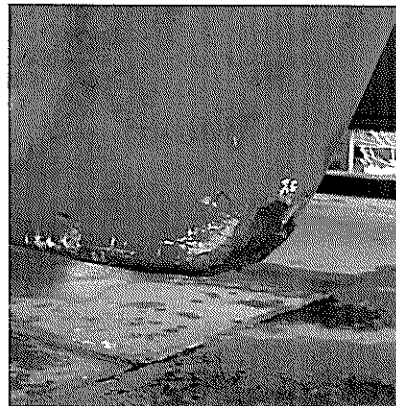
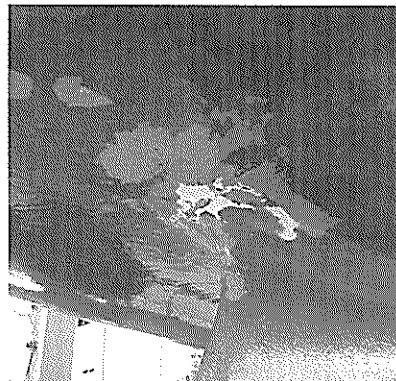
Well-let say after hitting some under water object that was not charted I'll show you. The speed we hit at was about 6 knots and all we needed was 6 inches more clearance. But all is good; we had to motor 5 hour to dock, even taking on water, the Catalina systems worked as designed (Another good job by the designers at Catalina). Repairs took most of the summer but she's back in the water good as new. Would we buy another Catalina or recommend one, you better believe it.

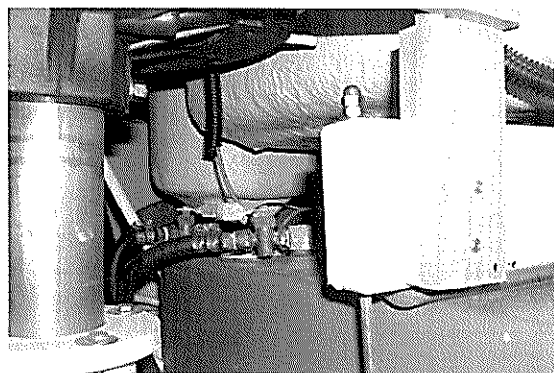
Catalina does have a recommendation for improving the current situation. The recommendation is to simply exchange the supply and return hose at the tank. In the picture you can see the supply and the return lines. There is ample hose to make the change without replacing or extending the existing hoses. By doing this the supply hose will now be drawing through the down tube located at closer to the centerline of the tank and the return will deposit fuel through the outboard down tube. If you think about the geometry of this you will see that the supply line will be immersed in fuel even when the fuel level is much lower than a half tank. Though it is not a perfect solution is should eliminate all of the problem. It also important to note that the engine manufacture recommends not running the engine when the angle of heel is greater than 25 degrees in either direction.

A few relevant facts about the C310 and the M-25XPB engine: 1) the fuel tank is mounted athwart ship at the stern and is slightly higher than the engine, 2) the fuel supply and return lines are attached to down tubes that protrude in to the tank to within 1/2" of the bottom (Hull 54 and newer), 3) the supply down tube is mounted

toward the starboard end of the tank and the return down tube is mounted closer to the centerline of the tank, 4) the MP25XPB is designed to run at a maximum angle of rotation of 25 degrees.

With the above information we can better understand what is happening when the engine stalls. As the boat heels to port with less than a half tank of fuel the supply line, being on the high starboard side of the tank, is out of the fuel supply and sucking air. The engine is starved of fuel and stops running. When the angle of heel is reduced the supply down tube is now back in the fuel supply and the fuel pump can once again draw fuel and supply fuel to the engine allowing the engine to restart.

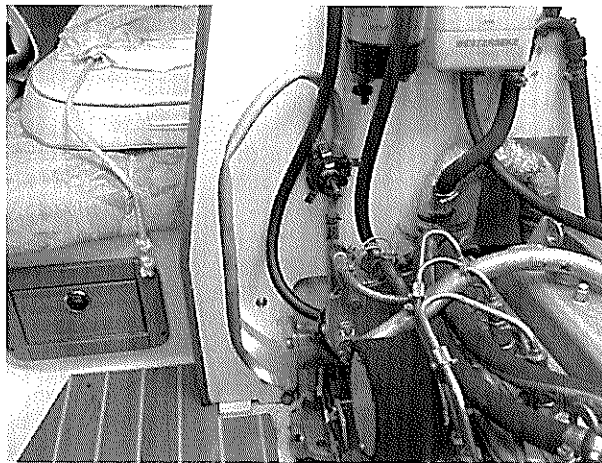
In order to make my oil change clean and easy I have installed a pump that is permanently connected to the oil reservoir. The installation is easy and inexpensive. I used a drill pump from WM. I mounted the small pump on the bulkhead inside the engine compartment as shown in the picture. Using some pieces of stainless steel strap I fastened the pump into place. I connected the inlet side of the pump to the existing hose that is connected to

the oil pan drain. On the outlet side of the pump I connected the hose that came with the pump. Using a 3/8" brass nipple and a brass cap connected to the outlet end of the hose I created an easily removable cap for the system.

When it is time for an oil change I warm the engine up to about 80 degrees. I connect my battery powered drill motor to the pump and remove the end cap from the outlet hose. I deposit the hose into a jug while turning the pump with the drill motor and in no time the sump is dry and you are ready for fresh oil. With a paper towel the end of the hose is whipped off and the cap is replaced to seal the system. -Bill

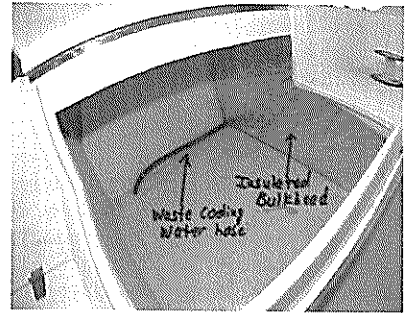
The unit I used, the 16,000 Btu, even though the 12,000 Btu would have worked fine, fits nicely in the port lazarette locker, in the forward aspect (Photo 1). I ordered mine with resistance heat since the lake water in the Midwest is very cold in the winter. You can also get reverse cycle heat from Flagship for use in warmer waters. I mounted it on a piece of plywood that I covered with epoxy for water resistance. I used 5200 to glue and seal it onto the floor of the locker. The return air grate/filter was cut into the floor of the locker as far outboard as possible. It sucks return air through the aft berth to keep it cool (Photo 7). I insulated the inside of the lazarette locker so that the outside of it, the part in the cockpit, would not condense water on the surface. I sealed the locker from the hull liner with spray foam. I also made a bulkhead from polyisocyanurate board to section off the part of the locker that contains the AC unit from the rest of the locker.

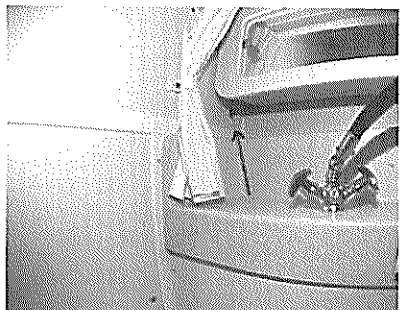
duct into the head (special order), I just ran it through the forward locker wall and ended it under the medicine cabinet so that shower water would not enter it, and it really is not visible (Photo 3). The other reason I put it there is so that AC

air would not blow the shower curtain open while showering. The air just goes under the cabinet and into the head area rather nicely.

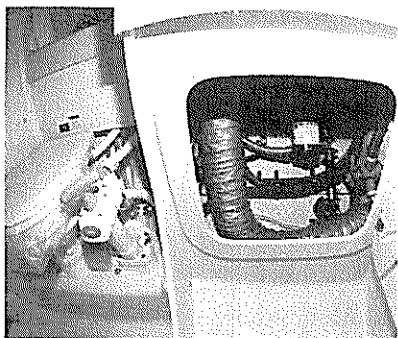
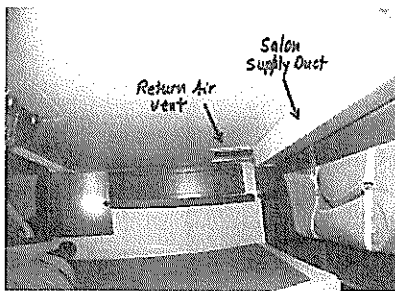
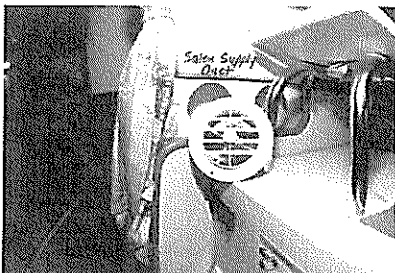
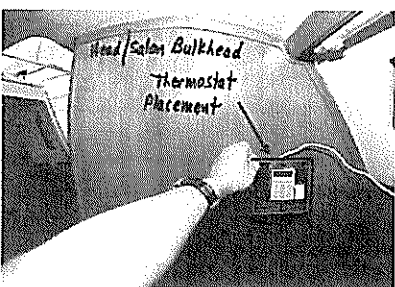
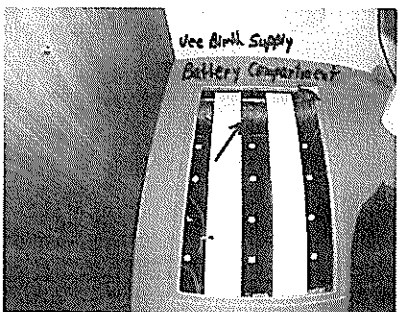
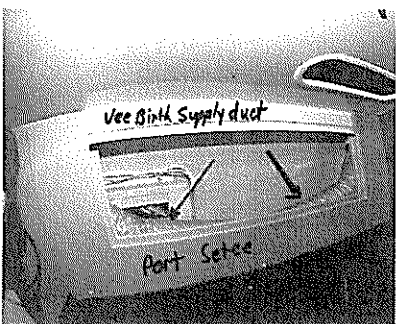
I ran the duct forward to the vee birth down through the outboard aspect of the floor of the locker, into the storage cabinet underneath and behind the head (that board comes out for access). It continued through the vanity cabinet, through the bulkhead and into the battery area. Heading forward I ran the duct through the port settee, and then into the locker in the eve birth. There I cut a hole in the front of the locker and used a directional vent to aim the air into the birth.

For the salon supply I bought a 4" PVC fence post (do not laugh until you see it, it was neat) from Home Depot to be used as a nice looking air duct since it will be visible. I ran two 4" duct hoses just through the floor of the lazarette and left a couple inches sticking through the ceiling of the aft birth. I glued them in place. I cut two 4" holes

in the top of the fence post and mounted it on the ceiling of the aft birth to connect with the two protruding 4" hoses. The fence post ran toward the starboard side, and stopped at the bulkhead cutout, where the curtain is cut to close the cutout, behind the engine. I cut two 4" holes in the front of the duct and mounted two directional vents. The air blows from the vents, under the top step of the engine cover, and into the salon. It has enough velocity that you can slightly feel it at the vee birth bulkhead. I used some Starboard to close the ends of the fence post/duct. You could use just about anything to close the ends though. Home Depot even had fence post caps. I decided the duct would look too much like it belonged on a farm if I used the caps.

I put the thermostat on the head wall by the port settee, next to the louvered cabinet door, slightly inboard (Photo 10). The whole system is silent. The only way a person would know if it were running, is that cold air is moving around the cabin. —Dr. Kevin Quade, *Hydrophilic*, #191.
